Bear Cabin Branch Stream Restoration

ECOTONE, INC

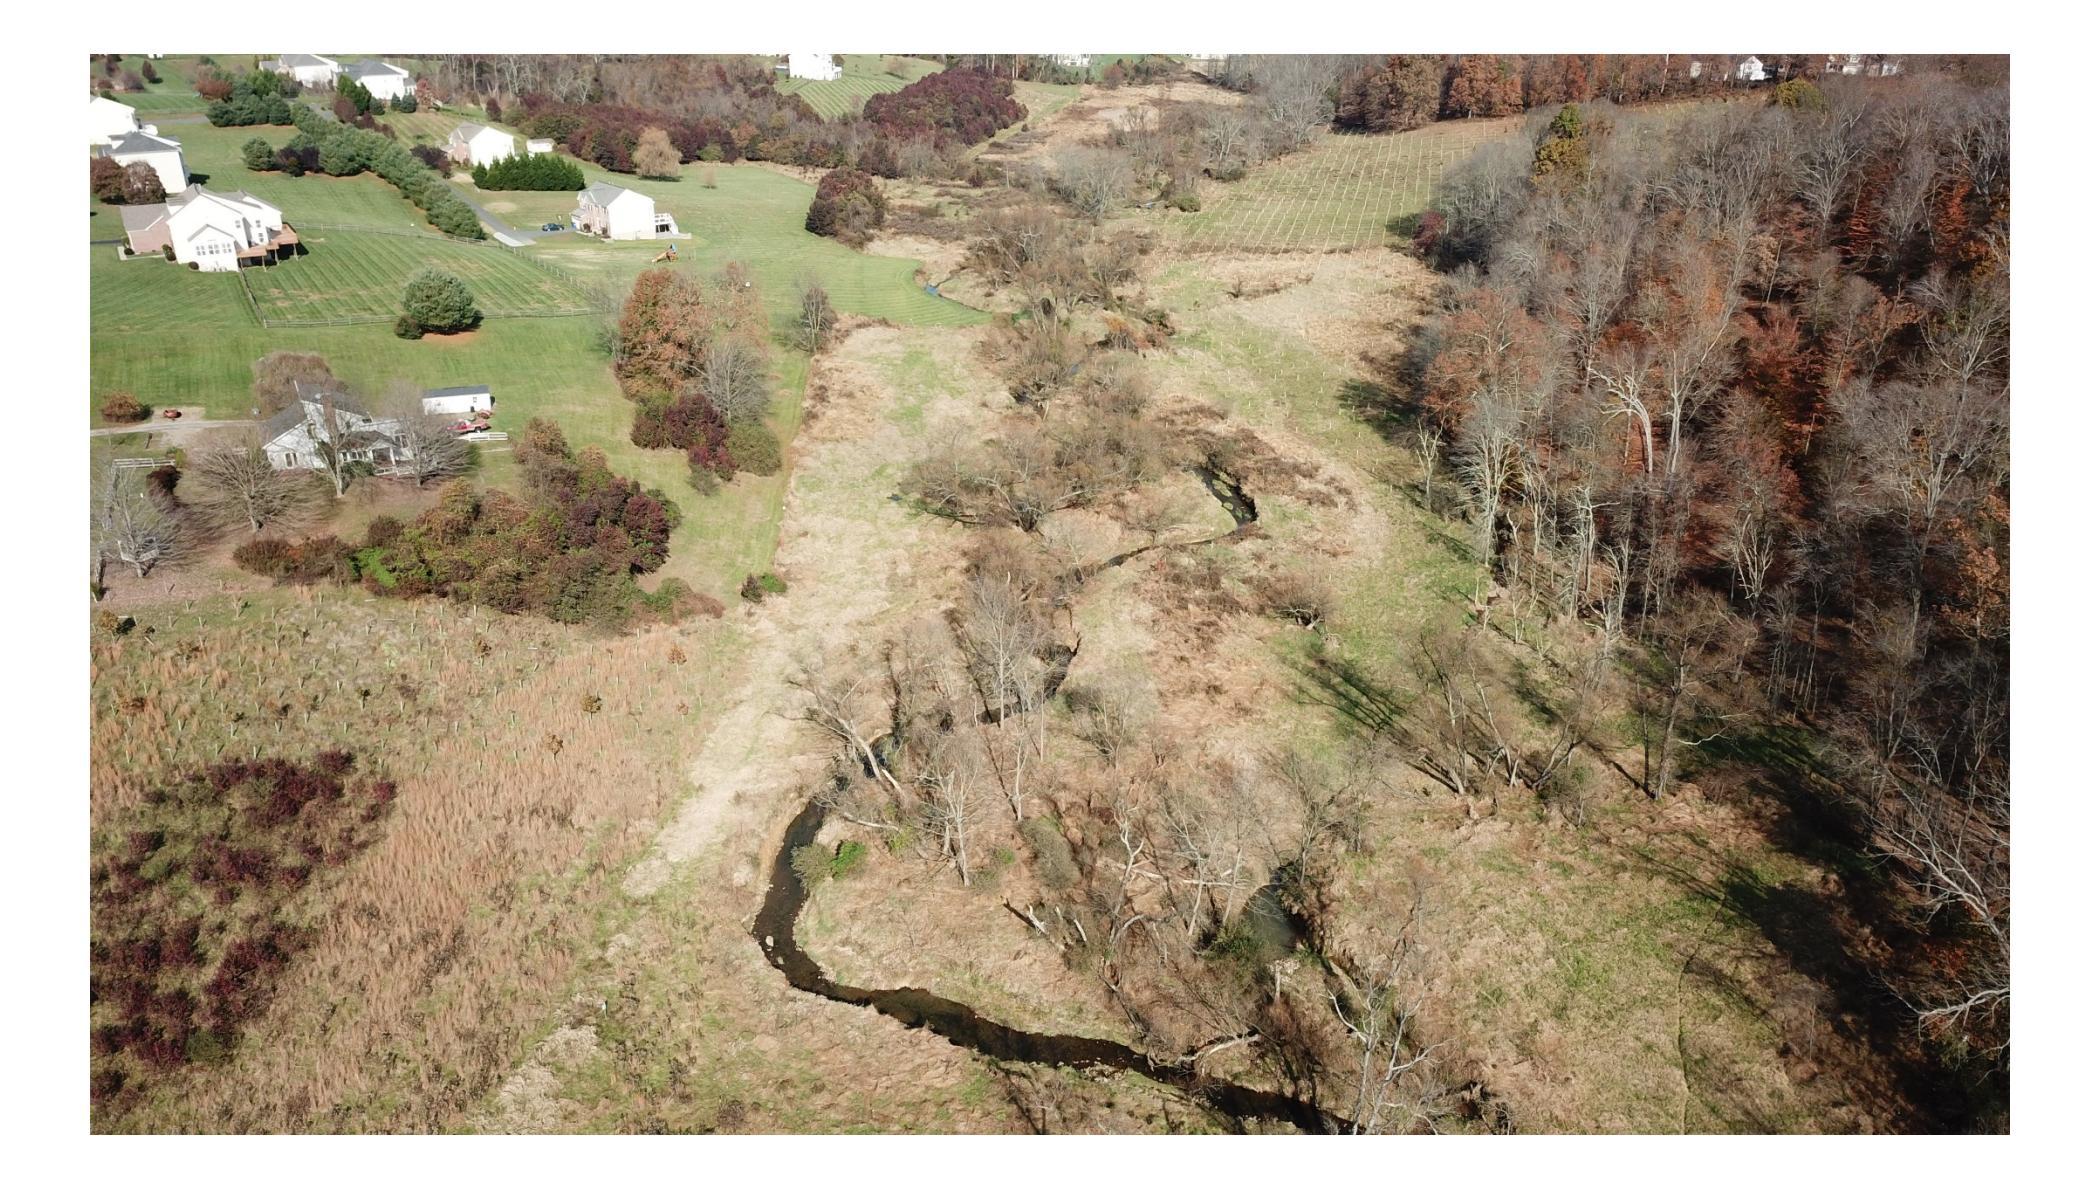
Before - Bear Cabin Branch was experiencing high bank erodibility, leading to tight meanders and barren banks.

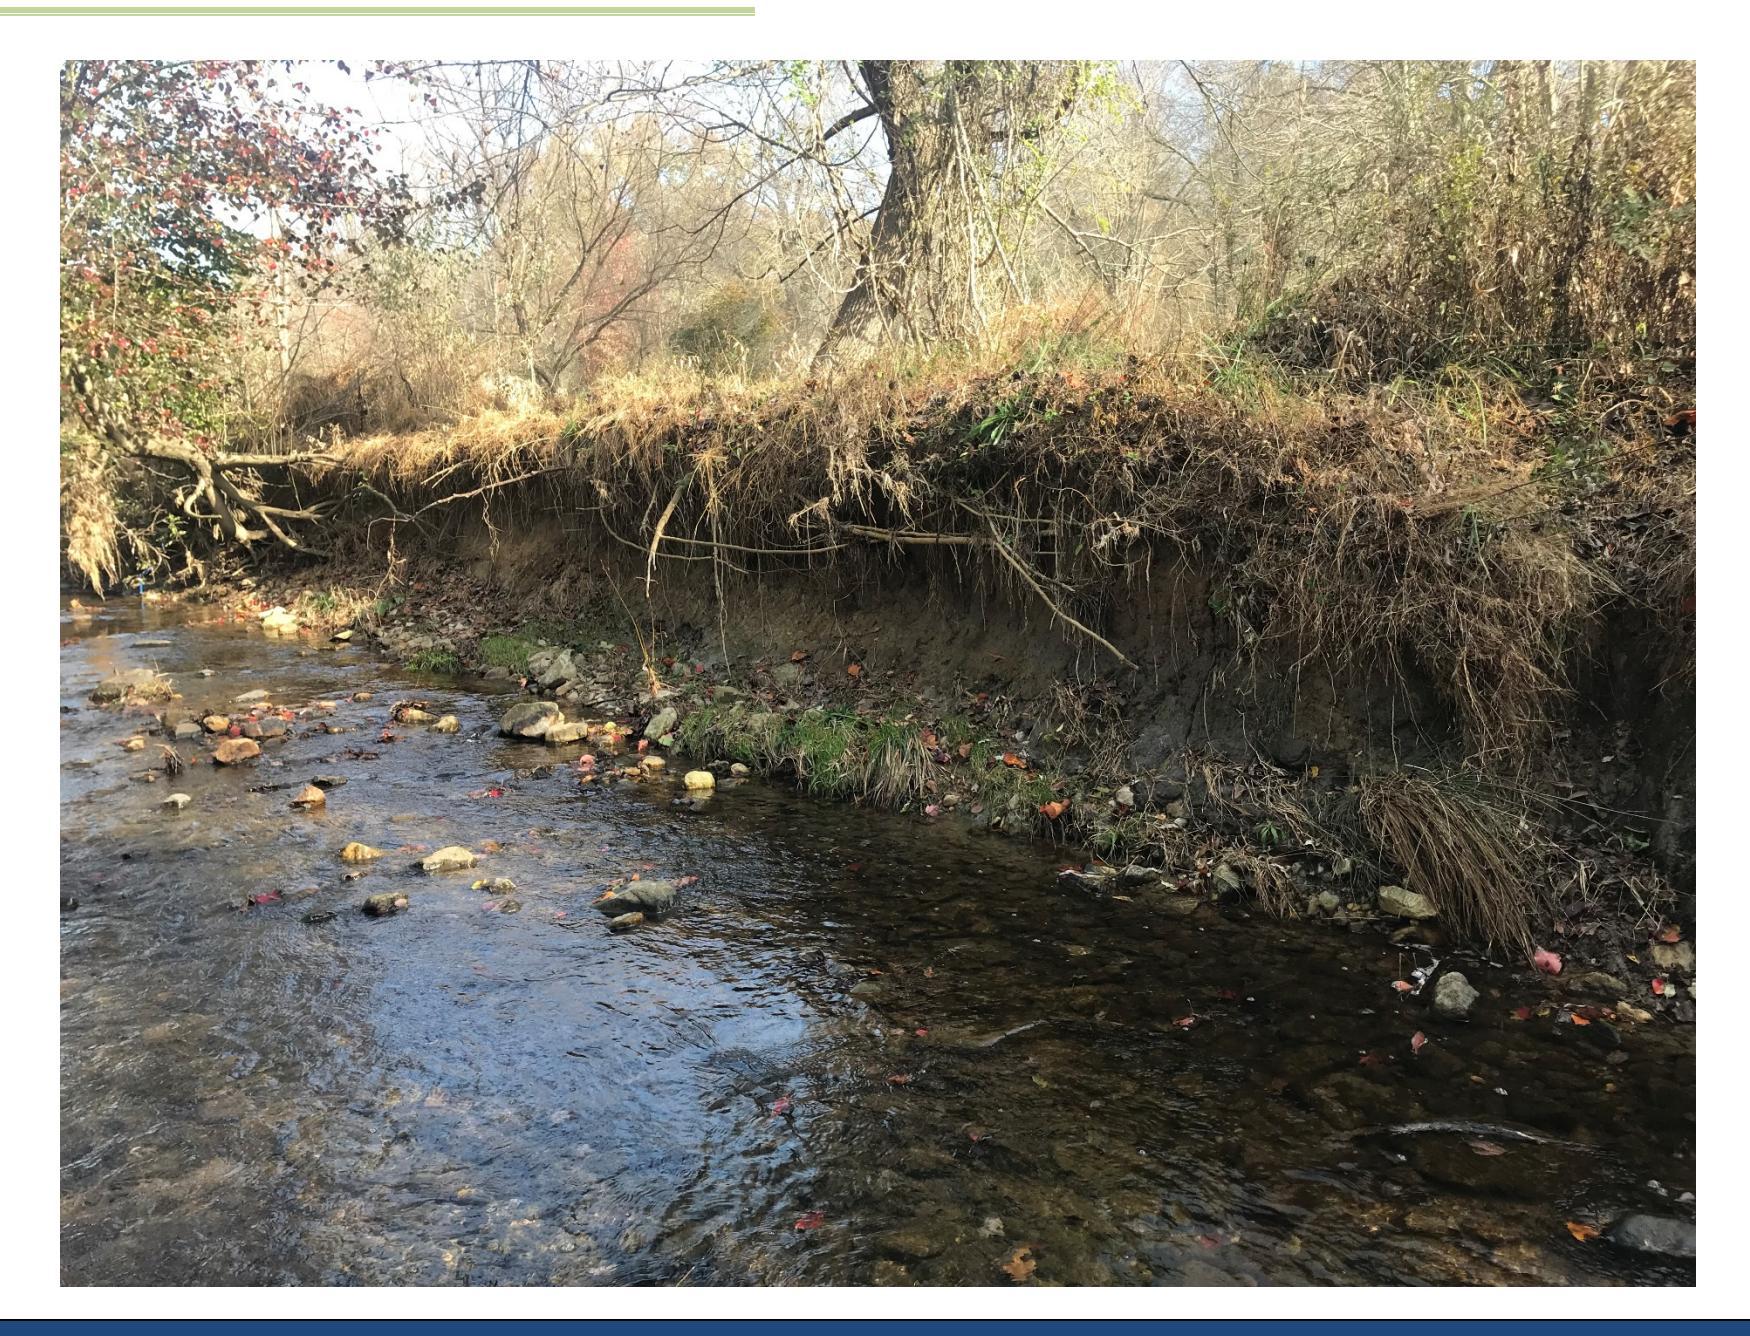
Before - Incised banks with little rooting depth led to severe erosion.

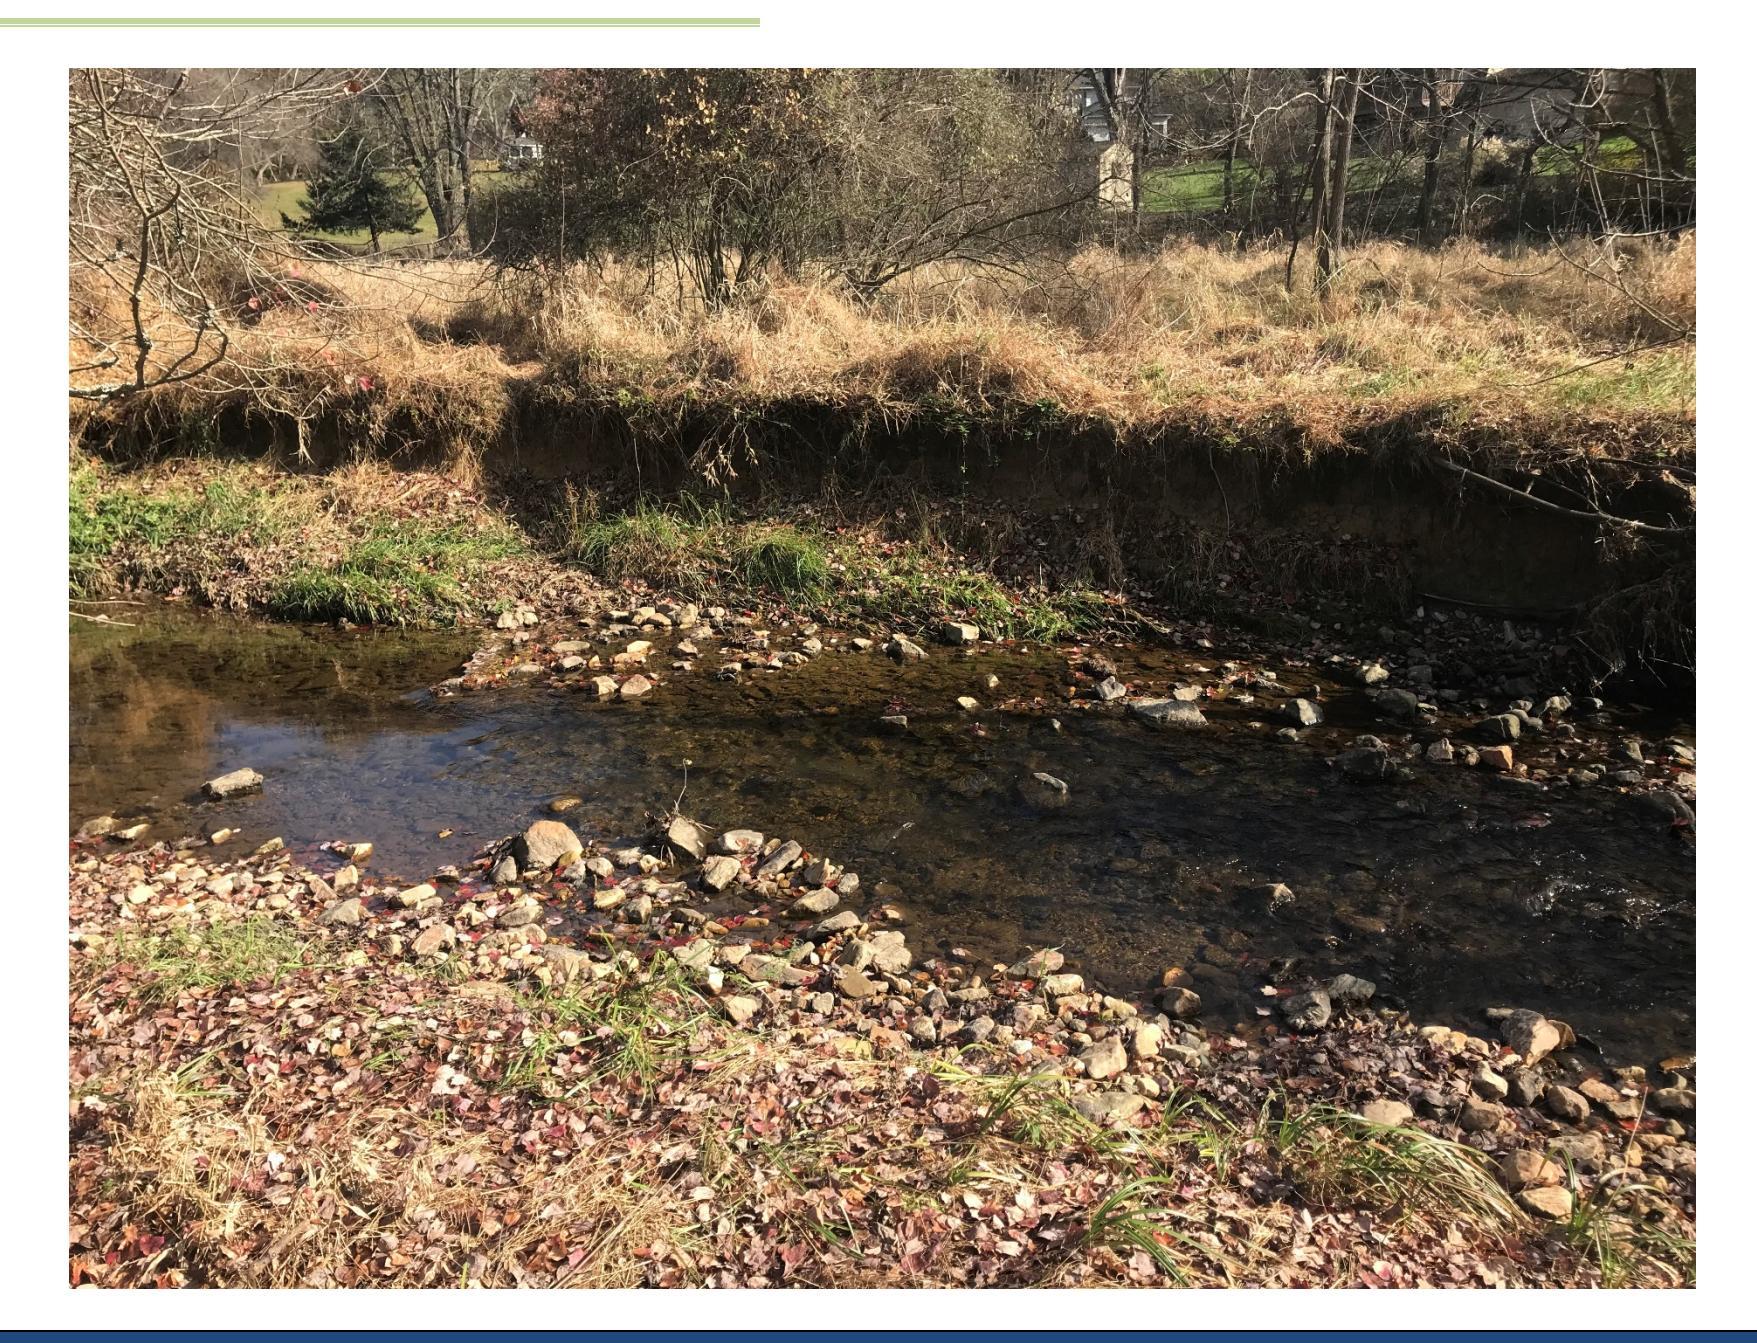
Before – Bear Cabin Branch was also isolated from its floodplain, preventing the water from escaping the channel to disperse energy during high flows.
