North Stirrup Run Stream Restoration

Project Overview

Site Location:
Harford County, MD

Client / Owner:
Harford County Soil
Conservation District

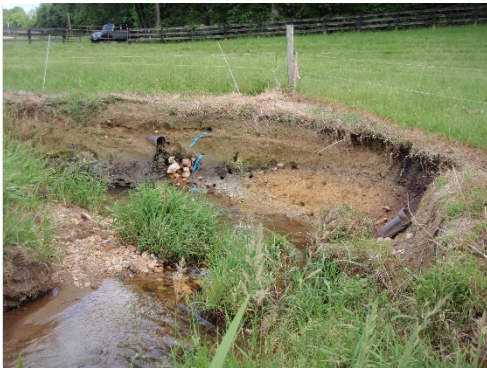
Prior to restoration, the stream showed significant signs of accelerated bed and bank erosion as well as meander migration. Potential causes of the degradation to the channel originate from long term flow regime change and a lack of riparian and streambank vegetation. The stream also was exhibiting signs of significant damage from livestock accessing the stream at multiple locations.

Prior to construction, stream banks were severely incised. The stream was overly-sinuuous, with many eroded meanders such as the one pictured above.

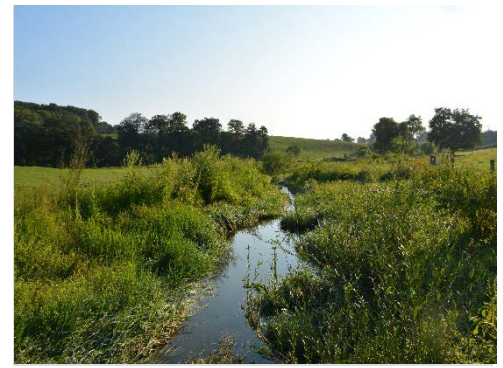
Now, North Stirrup Run exhibits a stable state with a robust riparian buffer and ample in-stream habitat. The stream's banks are no longer severely eroding and posing a threat to water quality.
