Stream Restoration Before & After

North Stirrup Run (2015)

ECOTONE, INC

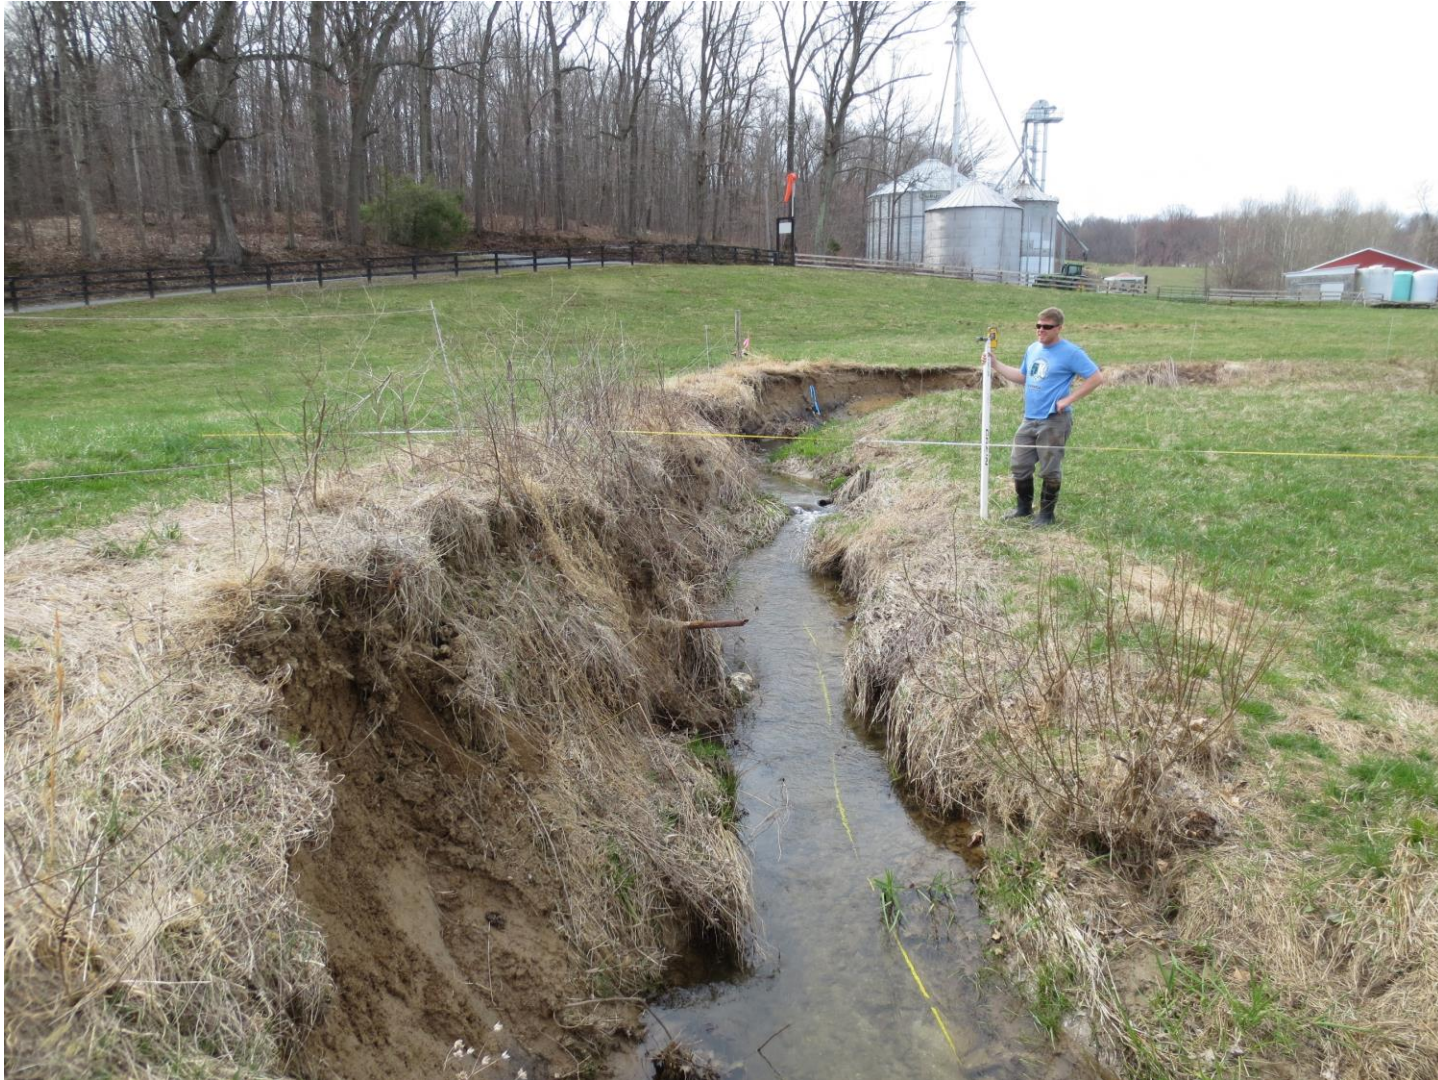
Before – Incised banks, high erosion, little vegetation on banks

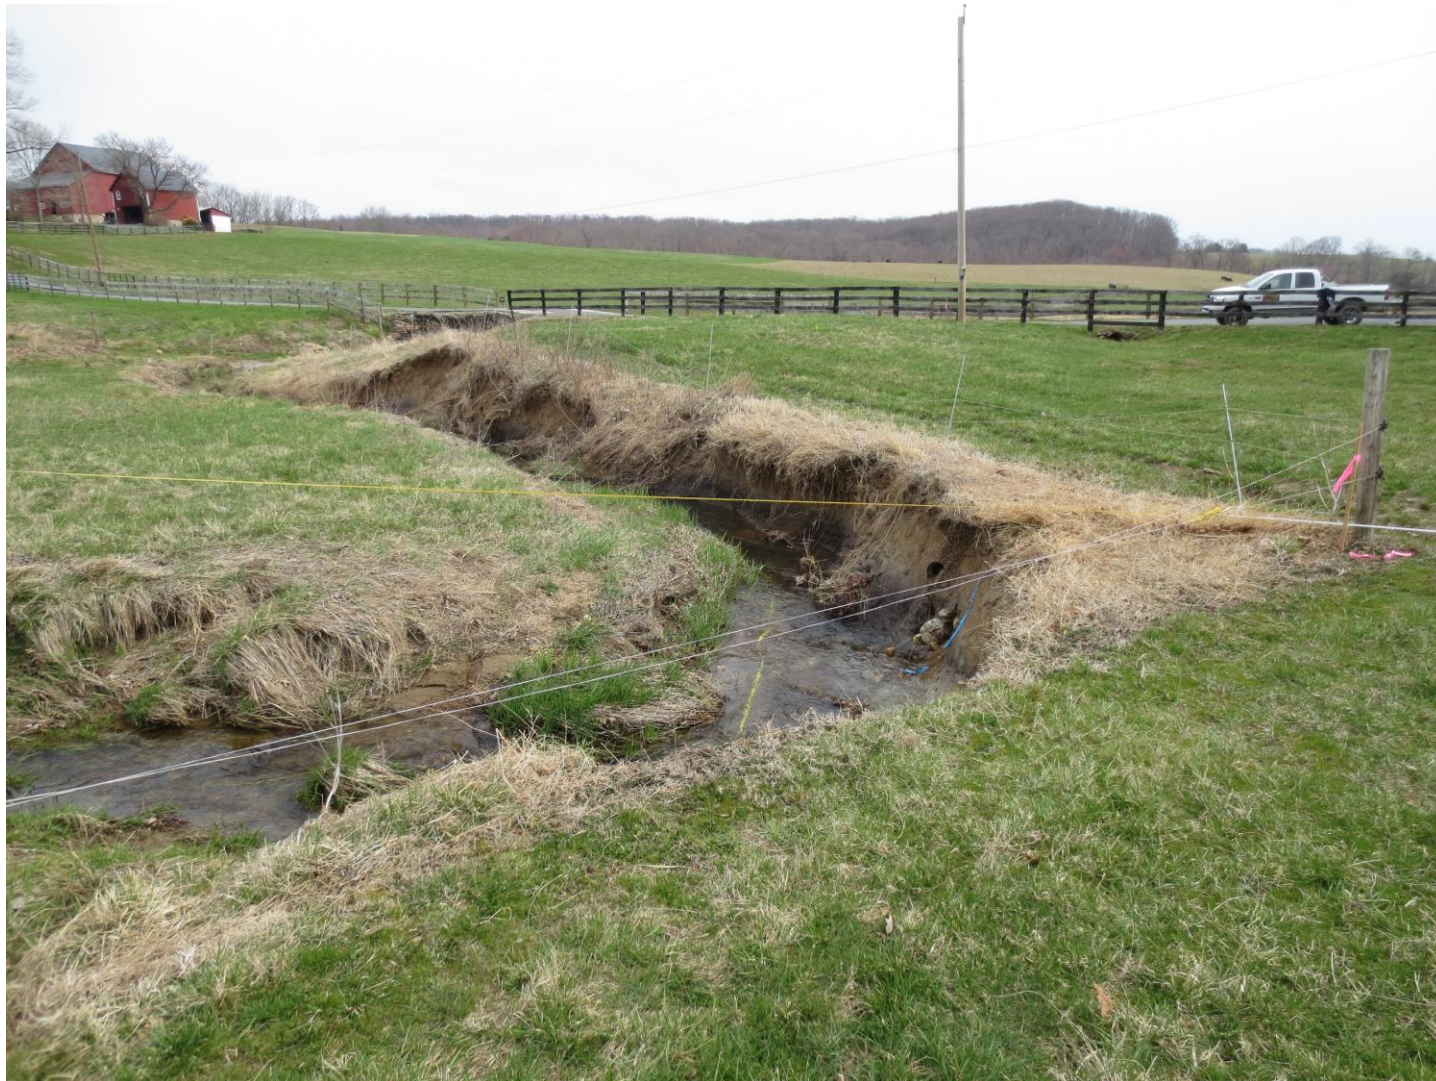
Before – Incised banks, high erosion, meandering stream

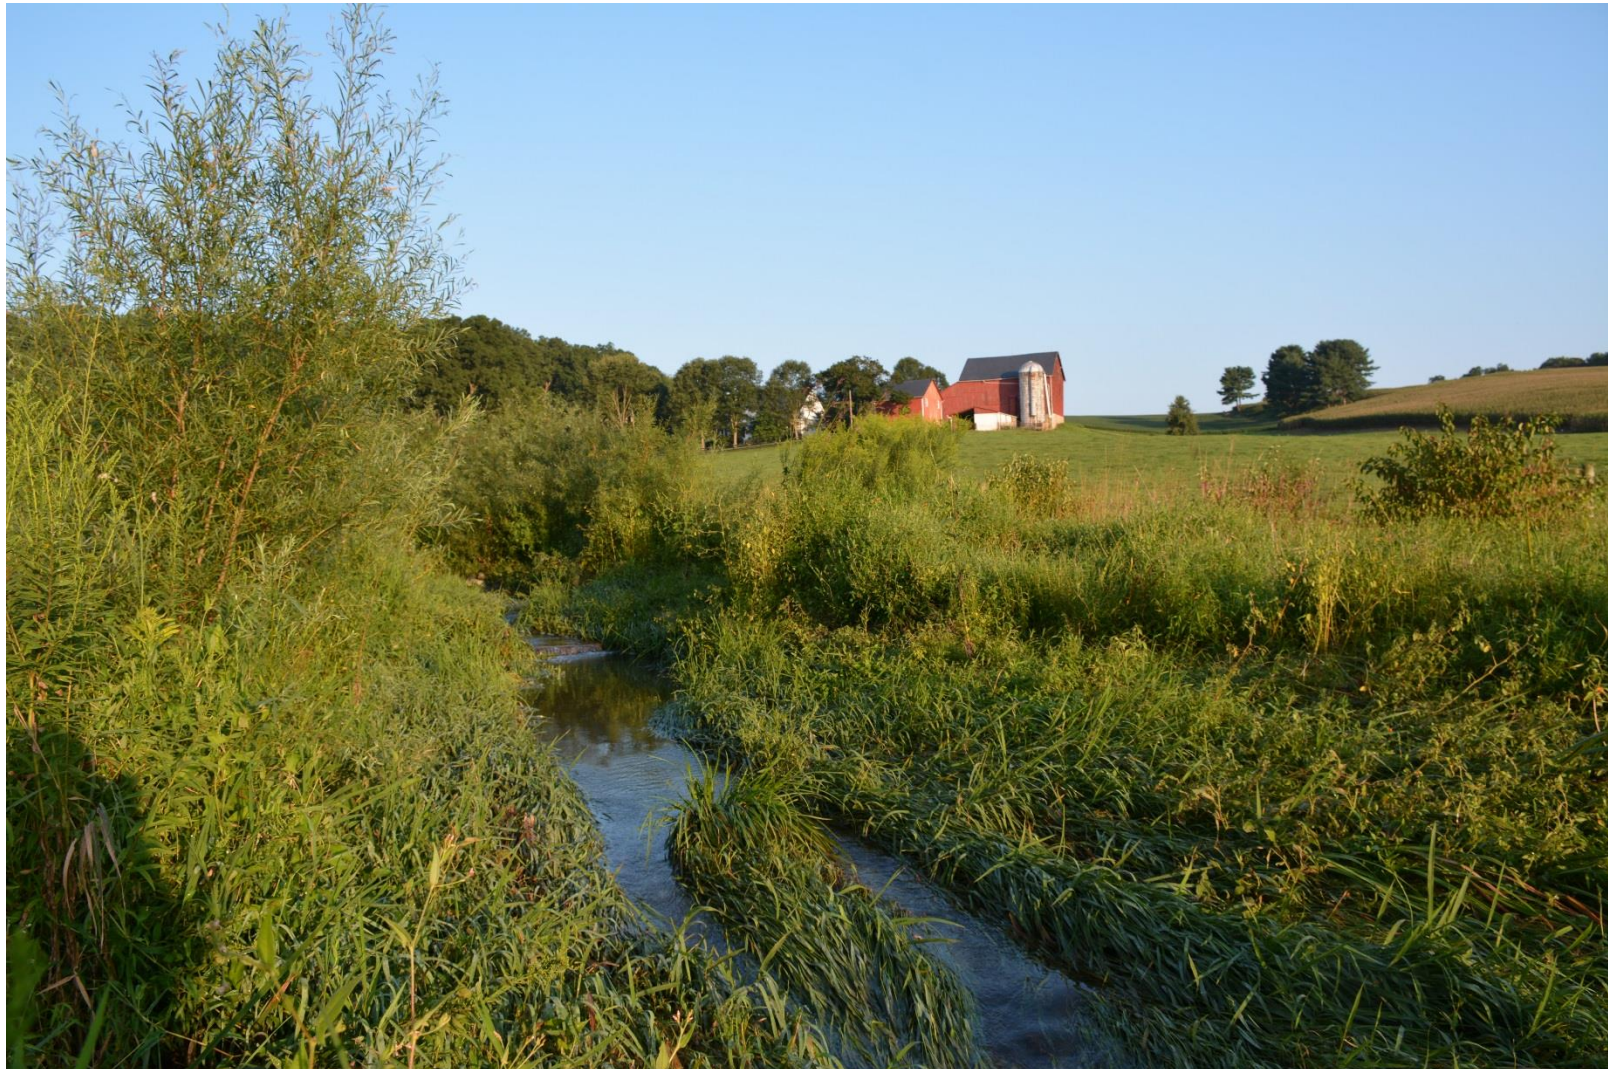
After – Portion of stream 3 years after construction

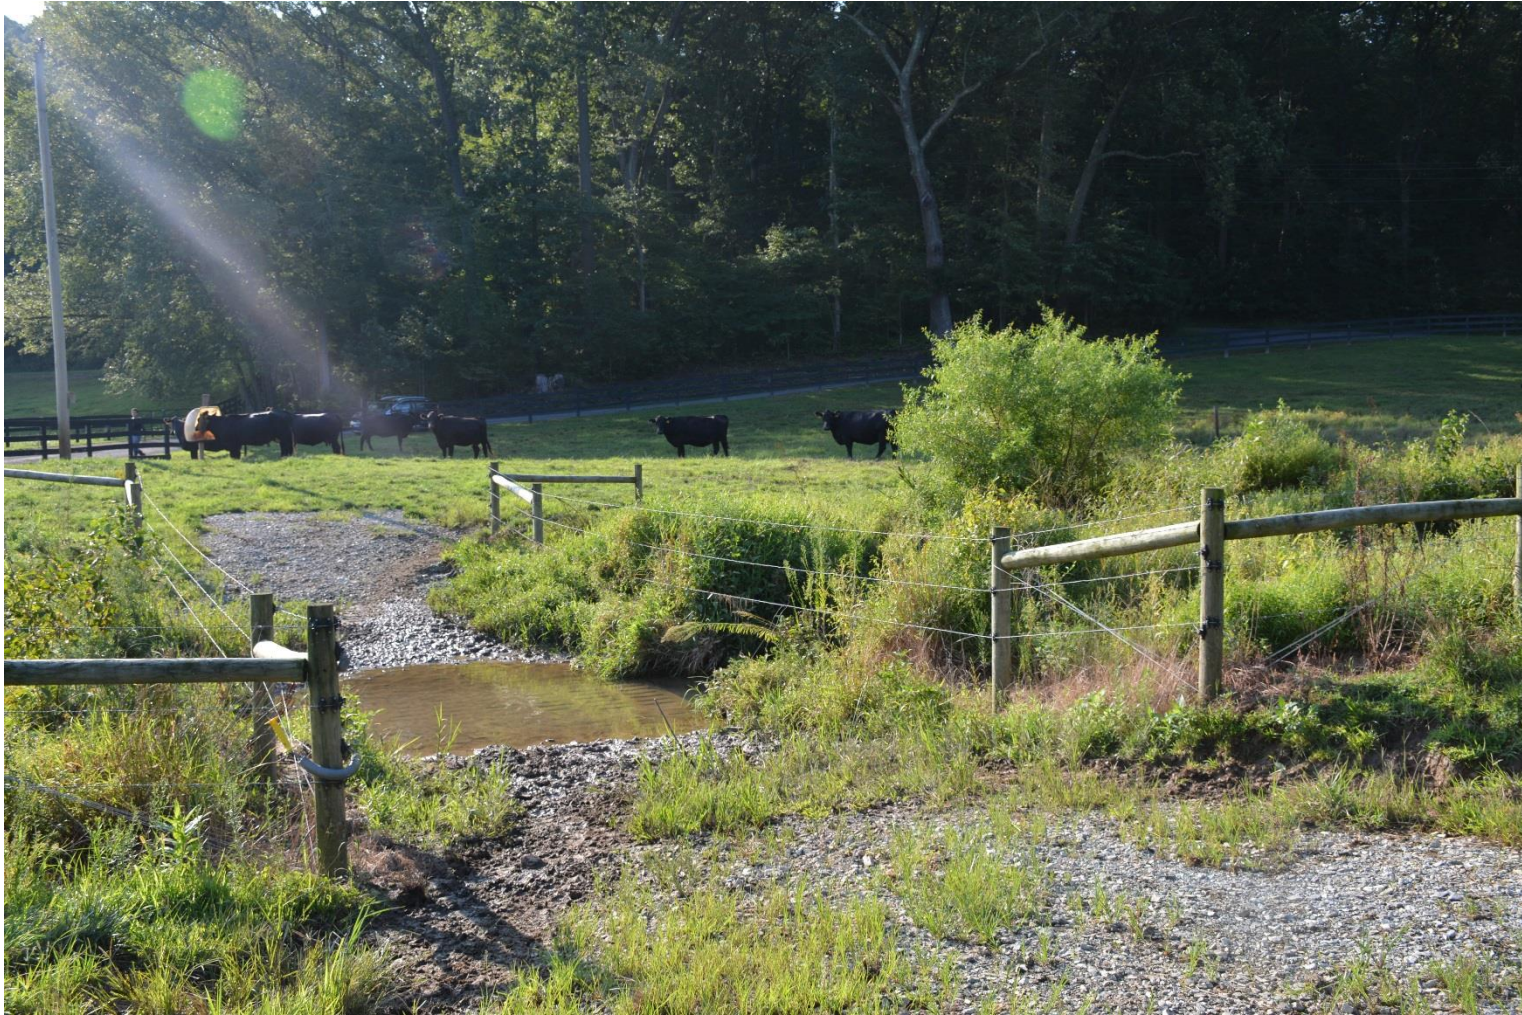
After – Livestock exclusion fencing and cattle crossing 3 years after construction
