Deer Creek Floodplain Restoration Project:

A Stage 0 Restoration Case Study in Western Oregon

Kate Meyer, Fisheries Biologist
U.S. Forest Service
Willamette National Forest, Oregon

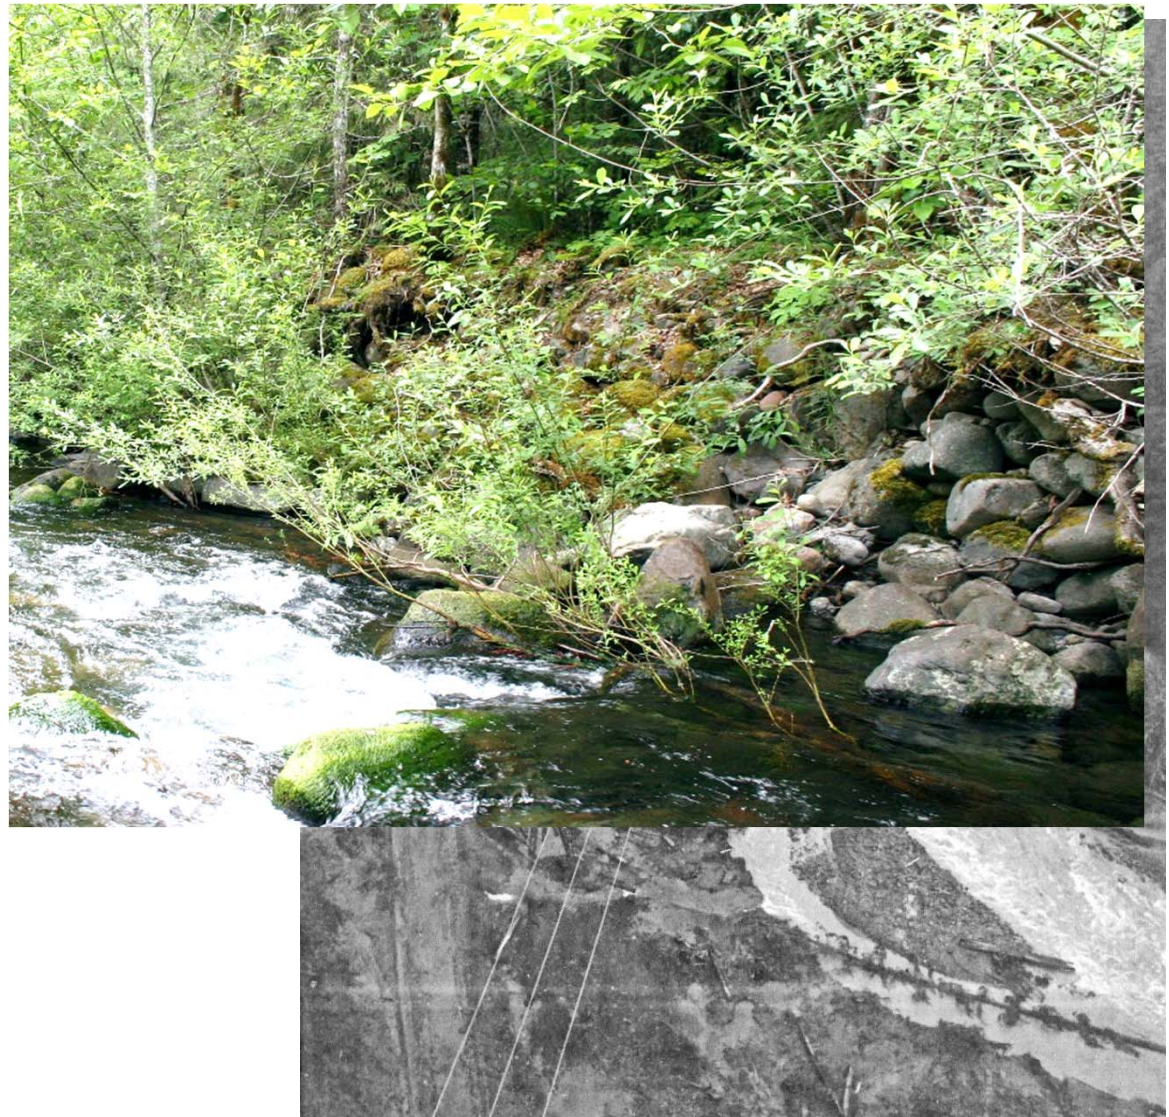
Land Management History

- Constructed berms channelized the stream...

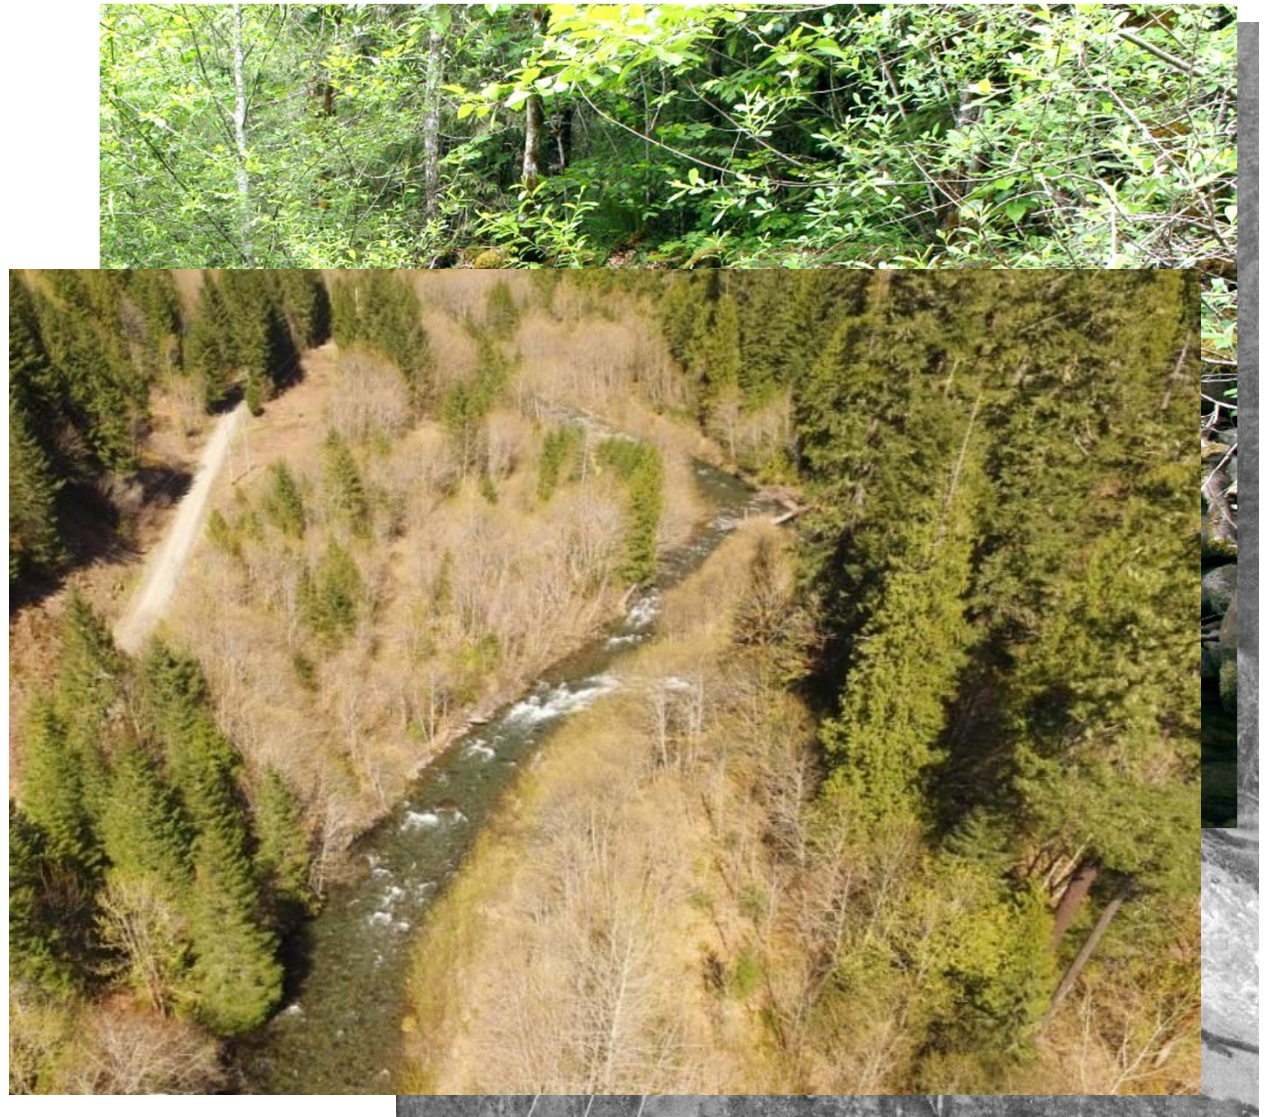
Land Management History

- ... and created a single-thread, transport channel with minimal floodplain connectivity

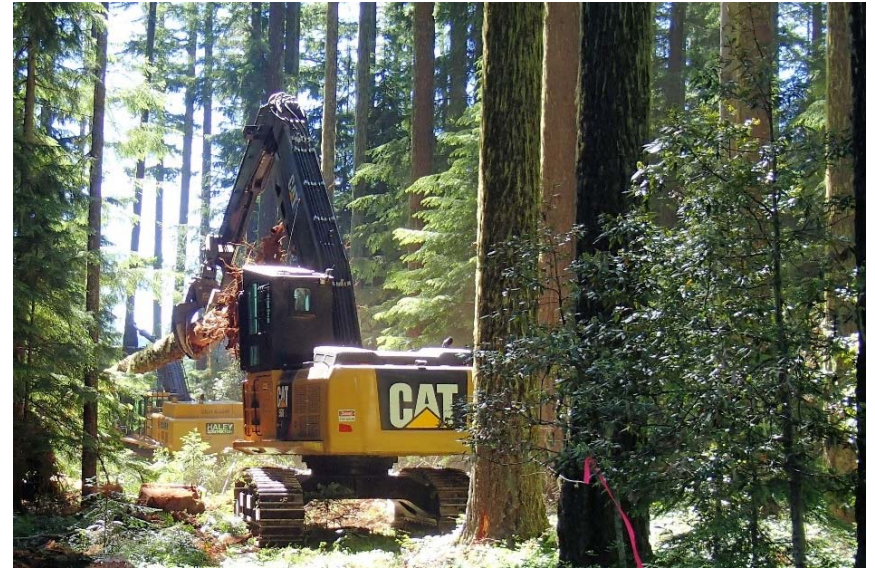
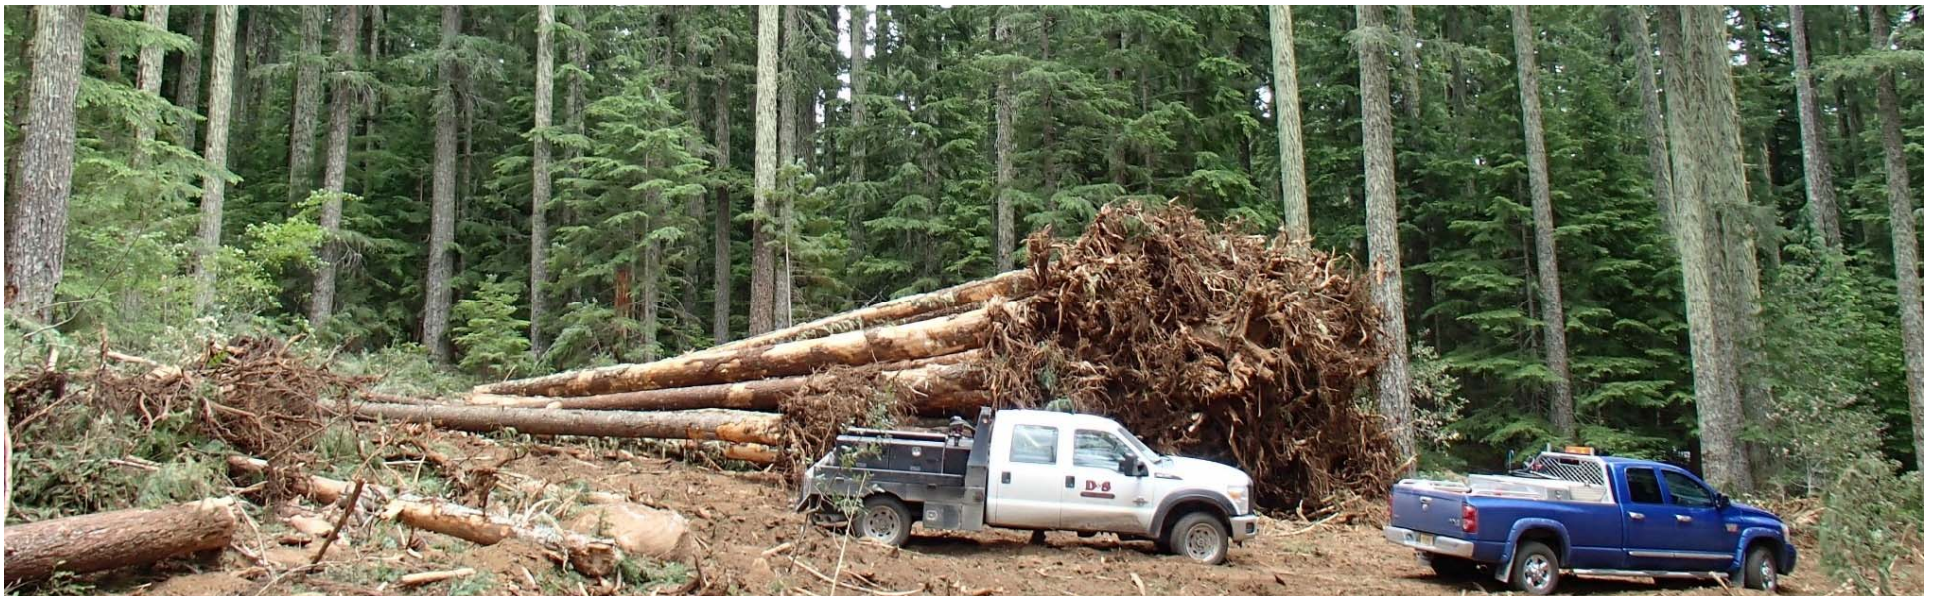
Implementation

- 200 trees (24-36" dbh) in upland units were pushed over, broken in half, and hauled down to placement sites

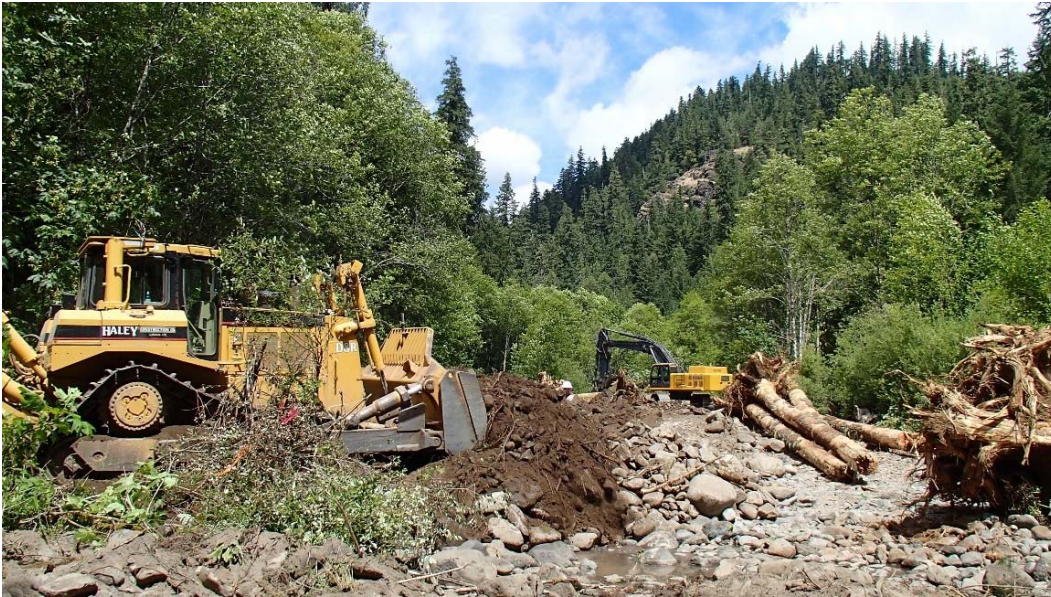
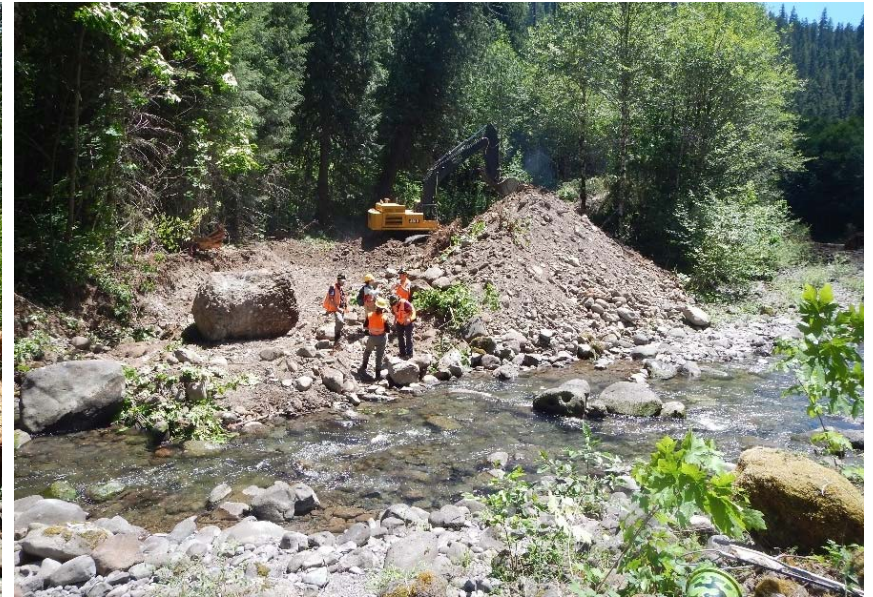
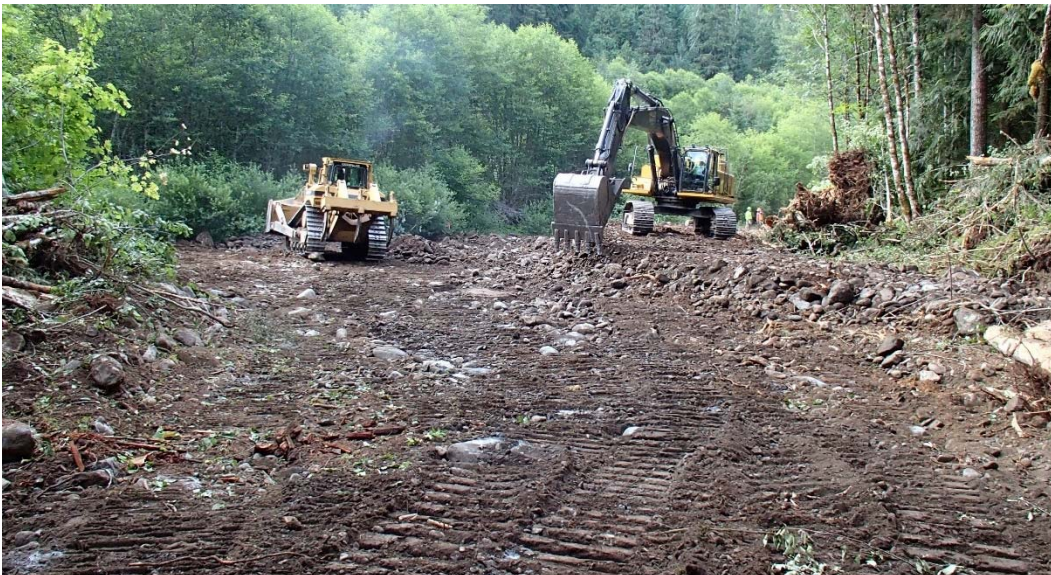
Implementation

- Berms were pushed into incised channel with a dozer and excavator

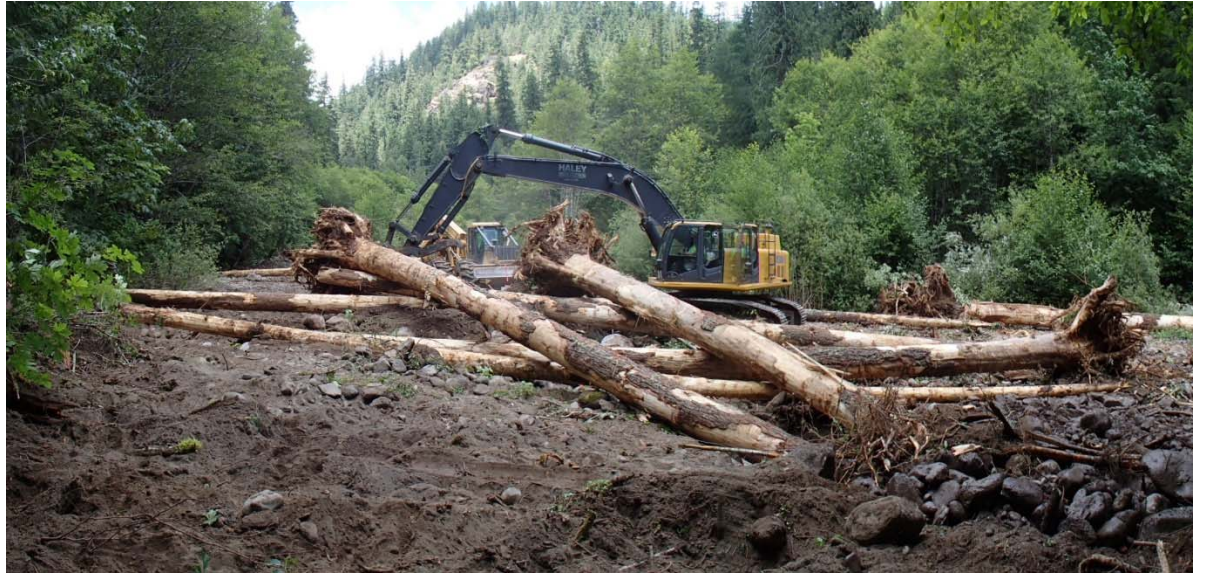
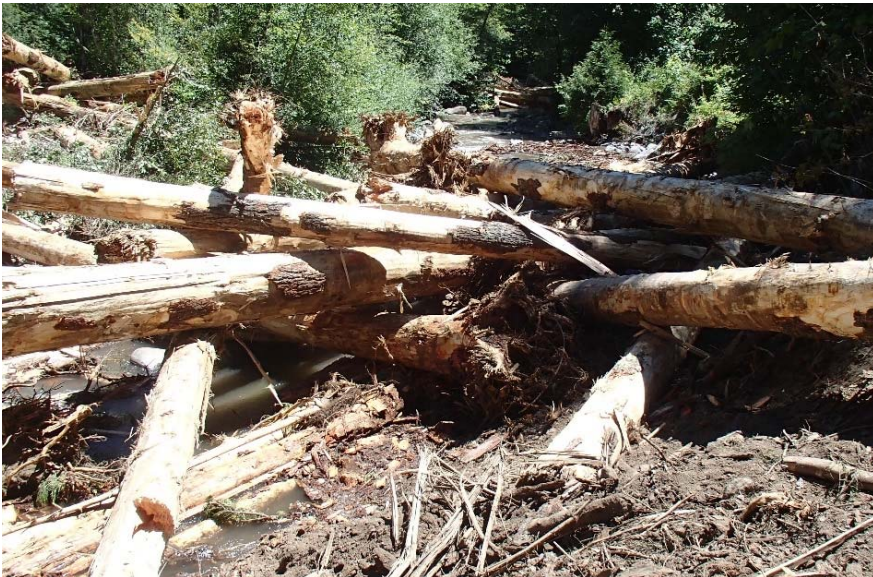
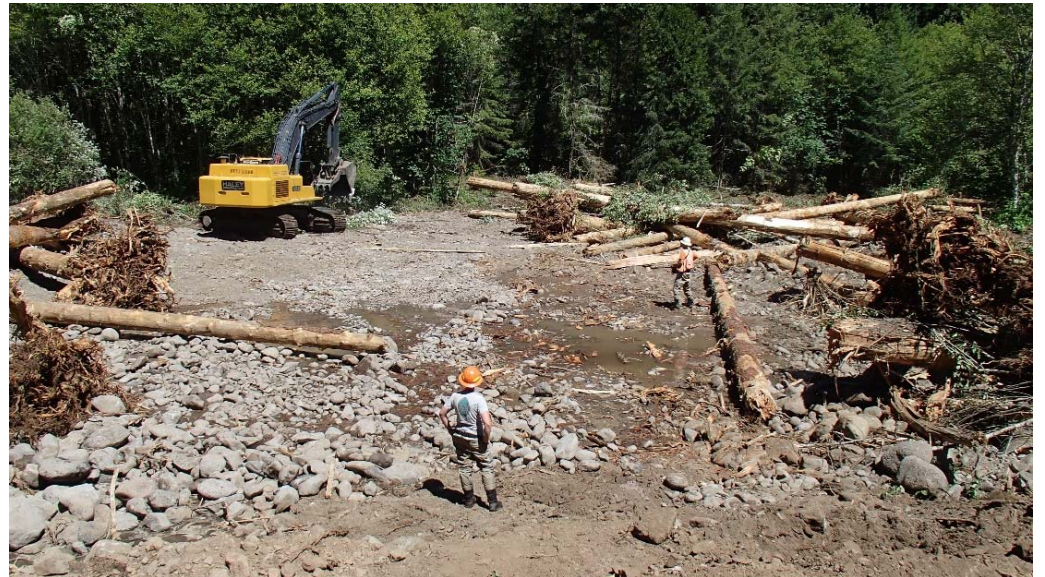
Implementation

- 450 pieces of large wood were placed in jams and single pieces throughout the valley bottom

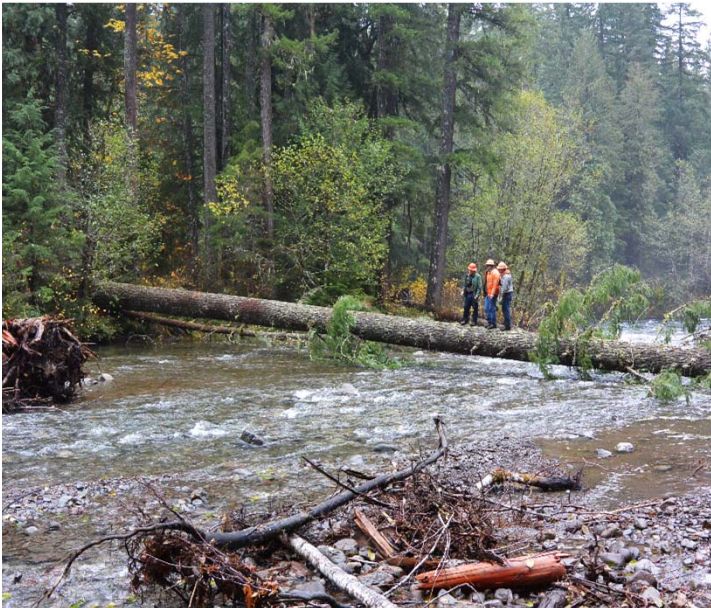
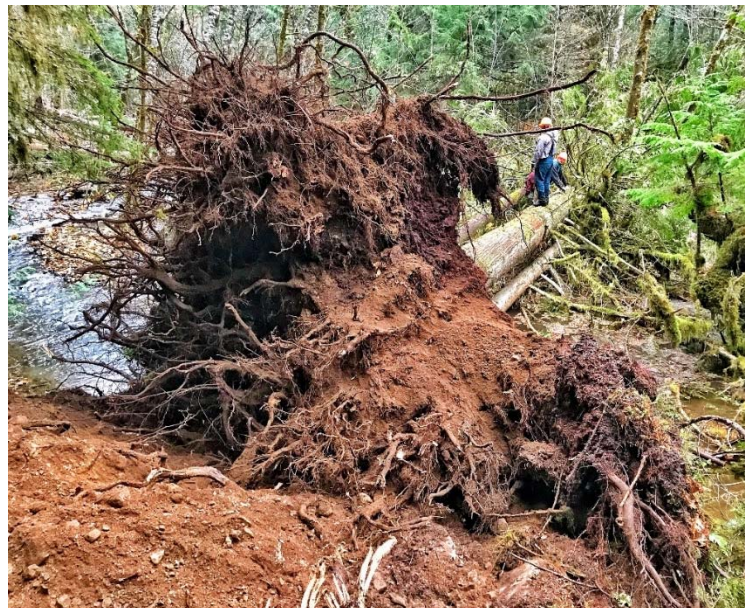
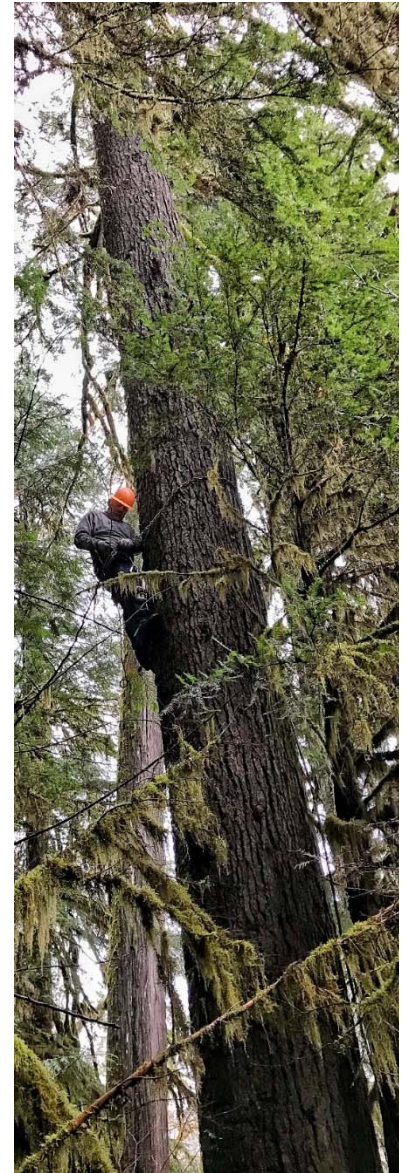
Implementation

- 25 streamside trees (38-63" dbh) were pulled over using a truck-mounted yarder to serve as large, stable key pieces

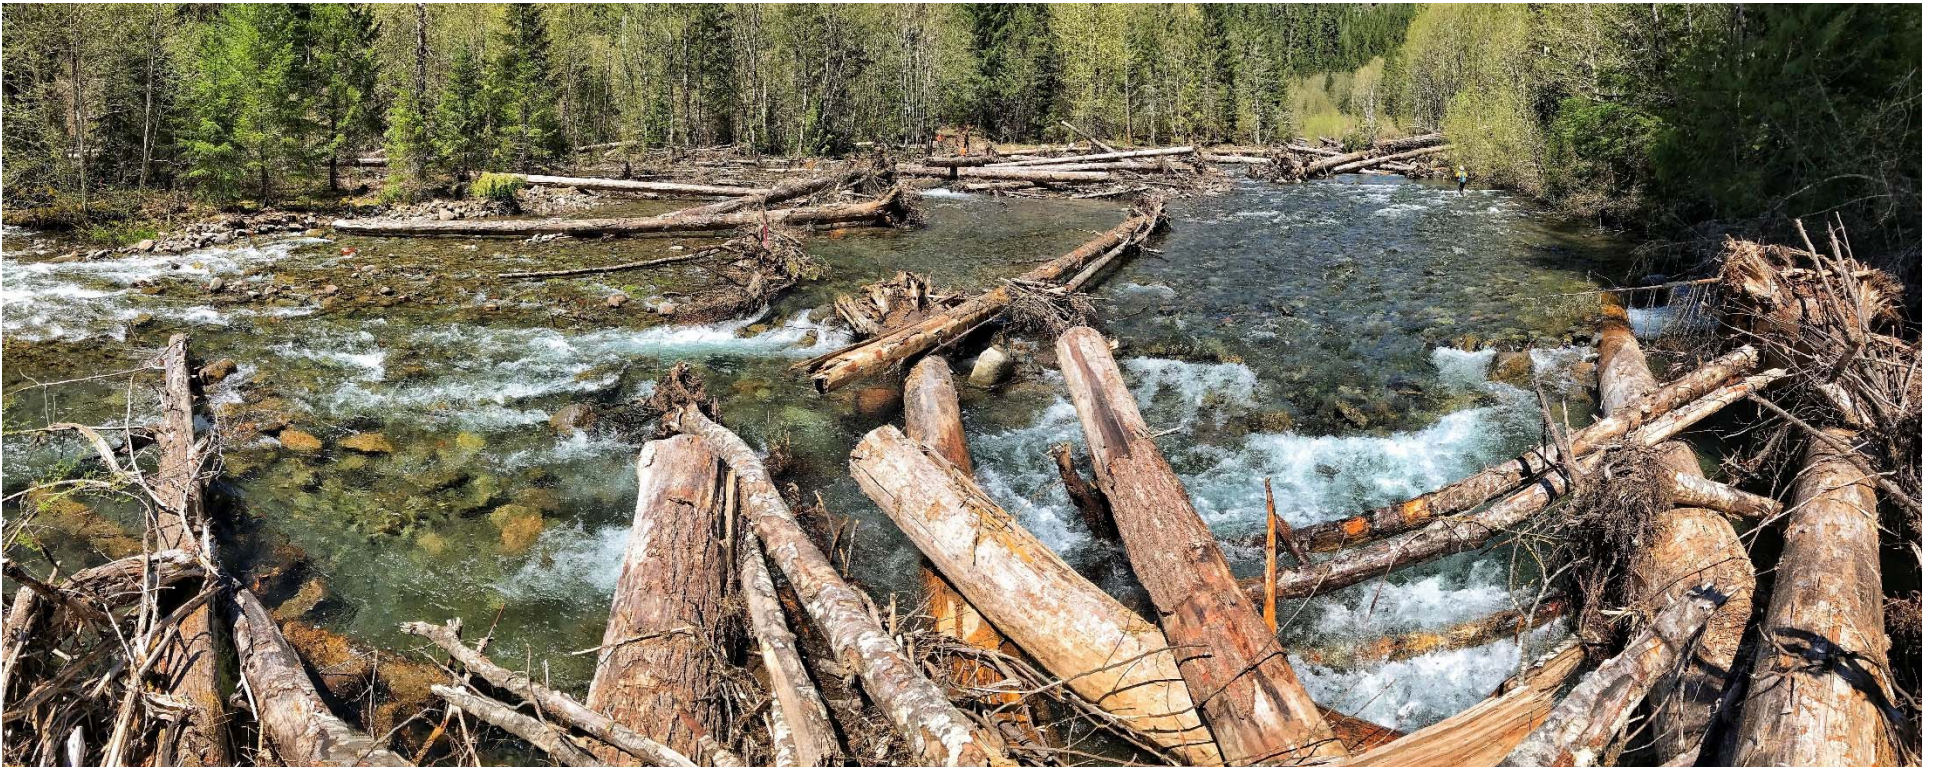
Monitoring Results: Before and After (1yr)

METRIC	BEFORE	AFTER	% INCREASE
LWM Density	20 pieces/mile (12 pieces/km)	317 pieces/mile (197 pieces/km)	1500%

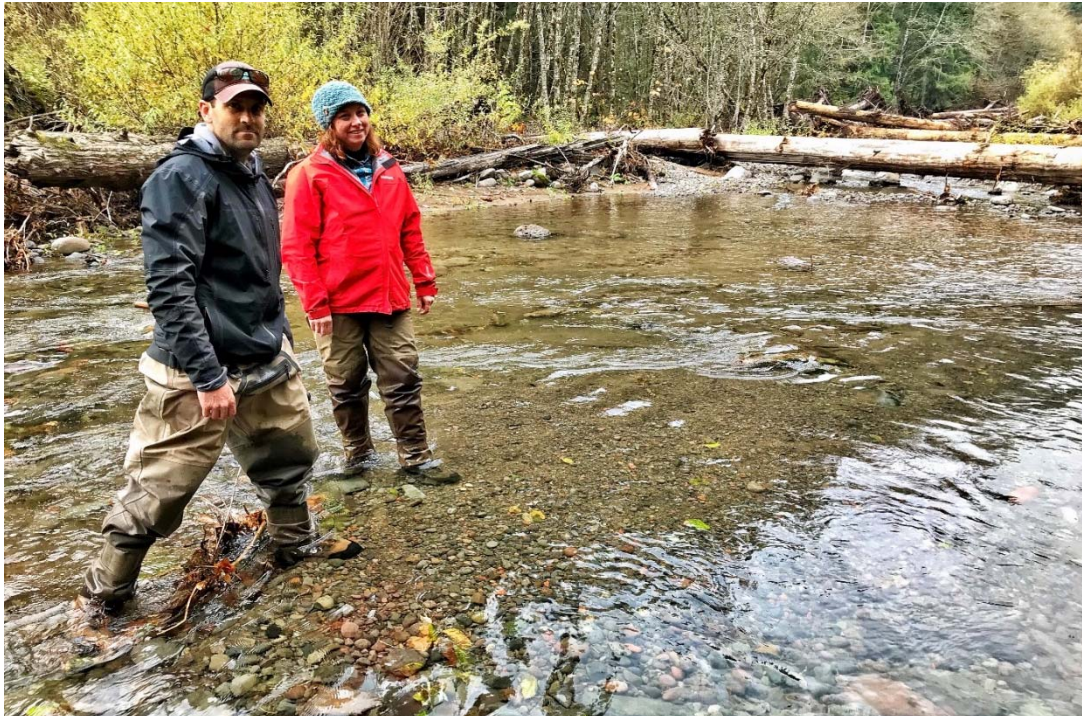
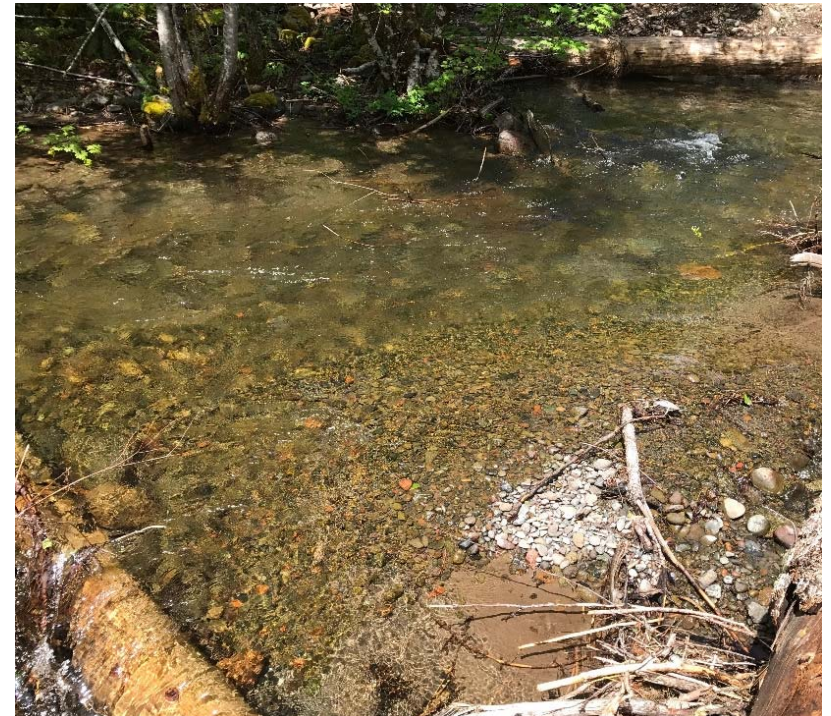
Monitoring Results: Before and After (1yr)

METRIC	BEFORE	AFTER
Median Particle Size of Pool Tailouts	64-90 mm Cobbles	45-64 mm Gravels
