Bear Cabin Branch Stream Restoration

Project Overview

Site Location:
Forest Hill, Maryland

Client / Owner:
Harford County
Government

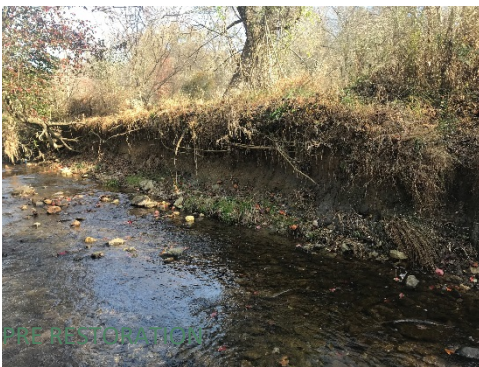
Bear Cabin Branch exhibited steep vertical banks exceeding 5 feet throughout portions of the reach, minimizing floodplain connection and increase near bank stresses.

Prior to construction the reach, classified as a Use-IV stream, exhibited high to extremely high bank erodibility, with very little rooting depth or density, bank angles greater than 70 degrees, and barren banks devoid of any effective surface protection. The channel had become incised, leading to shear stress along the near bank region during high flow events. The stream also had a large amount of legacy sediment present within its corridor, likely from past agriculture and urbanization within the watershed.

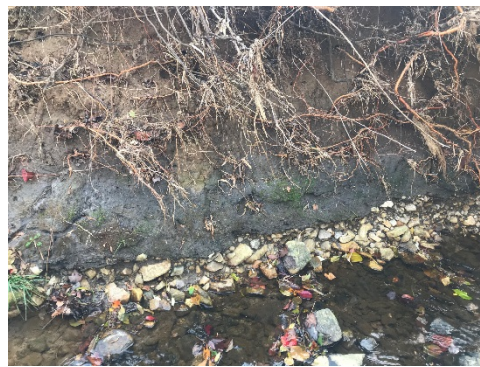
Bear Cabin Branch had large amounts of legacy sediment present on site, prior to construction.

The restoration focused on removing legacy sediment and reestablishing a connection to the floodplain. Large oxbow wetlands were established in the floodplain to further help dissipate energy during out of bank events. Rough grading within the floodplain was established to create areas of microtopography to increase habitat and slow velocities during high flows.

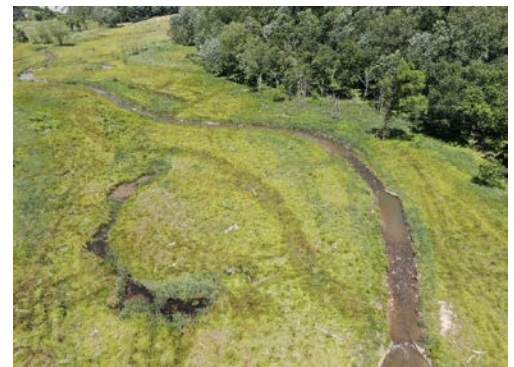
After construction high velocities were reduced as a result of reestablishing floodplain connection, the creation of oxbow wetlands, and microtopography grading with the floodplain.

Immediately after construction, the site began to establish vegetation rapidly, which has assisted in providing stability as the restoration becomes settled. The site has fared well after many large storms following construction. The site has already proved to provide habit for a variety of aquatic animals and birds. This project resulted in nutrient reductions of 216.75 lbs N/year, 31.96 lbs P/year, and 10.5 tons TSS/year.
