# WORKING WITH BEAVER TO RESTORE SALMON HABITAT IN THE BRIDGE CREEK INTENSIVELY MONITORED WATERSHED

## DESIGN RATIONALE & HYPOTHESES

### INTERIM REPORT

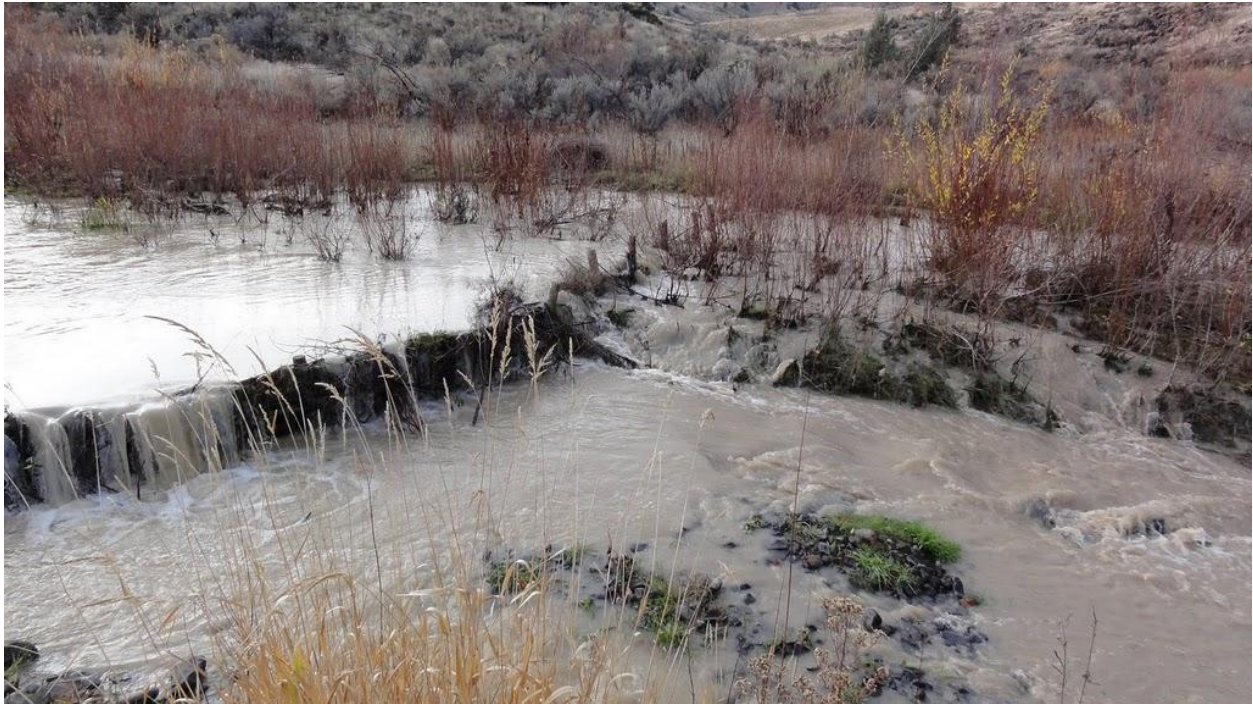
**Figure 10.** A typical starter dam (SF-17 at Sunflower) with willow branches woven between vertical posts and the back side sealed with rock and clay. Note the dam height is sufficient to divert flow onto the RL terrace, mimicking a stable beaver dam.

Starter dams (Figure 10) had the most criteria for siting. Generally, they were placed in locations where:

1. The water elevation upstream of the dam could be raised to the level of a terrace, so that flow would be dispersed across the terrace and it would be less likely that the structural integrity of the dam would be compromised.
2. The incision in the surrounding area was generally less than 1- 1.5 m so that additional dams that were built were more likely to be stable.
3. The backwater from the pond would provide access to soft banks upstream of the dam, which would act as suitable locations for bank lodges
4. There was adequate access to existing food and building supplies (e.g. existing wood and riparian vegetation)
5. There was no existing beaver colony nearby (i.e. within 300 m)

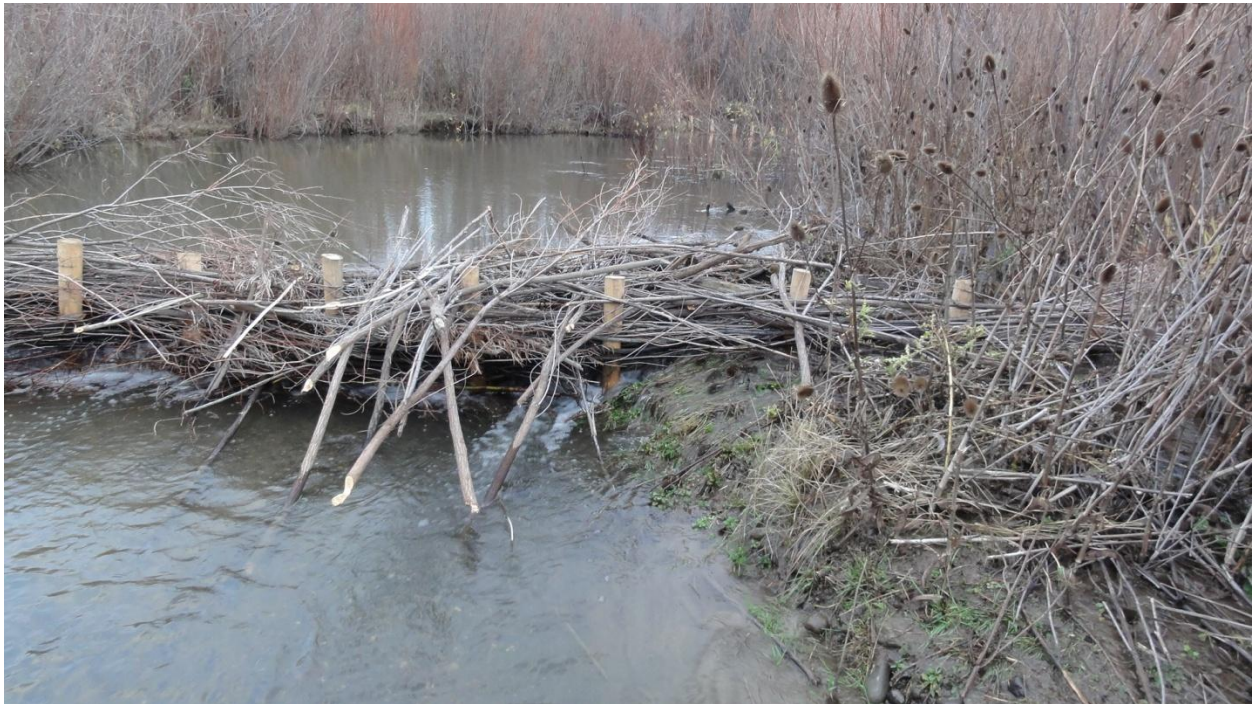
**Figure 11.** A post line with wicker weave is similar to a starter dam, but acts more like a weir in that water is allowed to flow through the willow branches such that low flows are not over topping the structure and the woven branches may not extend to the top of the posts. These may naturally seal up by trapping sediment and organic material moving downstream or they may be utilized by beaver. Note that beaver have started to colonize this PLWW, as evidenced by the chewed stems on the right of the photograph, aligned parallel to the flow.

Post Lines with Wicker Weaves (Figure 11) were the most common type of structure installed and served a variety of purposes. They were always placed where aggradation was both desirable and deemed geomorphically plausible to increase channel access to stream adjacent terraces. PLWWs mimic the functional impact of beaver dams in the short term, and were used to invoke a geomorphic response

A notable distinction between the wicker weaves and beaver dam construction techniques, is the orientation of the woody material. Beaver place many of the branches on the dams parallel to the flow (e.g. see Figure 11). This creates a wider downstream dam face or mattress of material and may help to minimize downstream scour relative to the wicker weaves. The wicker weaves are placed perpendicular to the flow because that is a more efficient use of building materials. Moreover, in monitoring beaver activity and colonization of wicker weaves, it is much easier to spot beaver activity and colonization of

BDS structures by the placement cuttings parallel to the flow (Figure 11). By contrast, woody debris and branches that wash down and rack on the dam tend to orient themselves perpendicular to the flow.

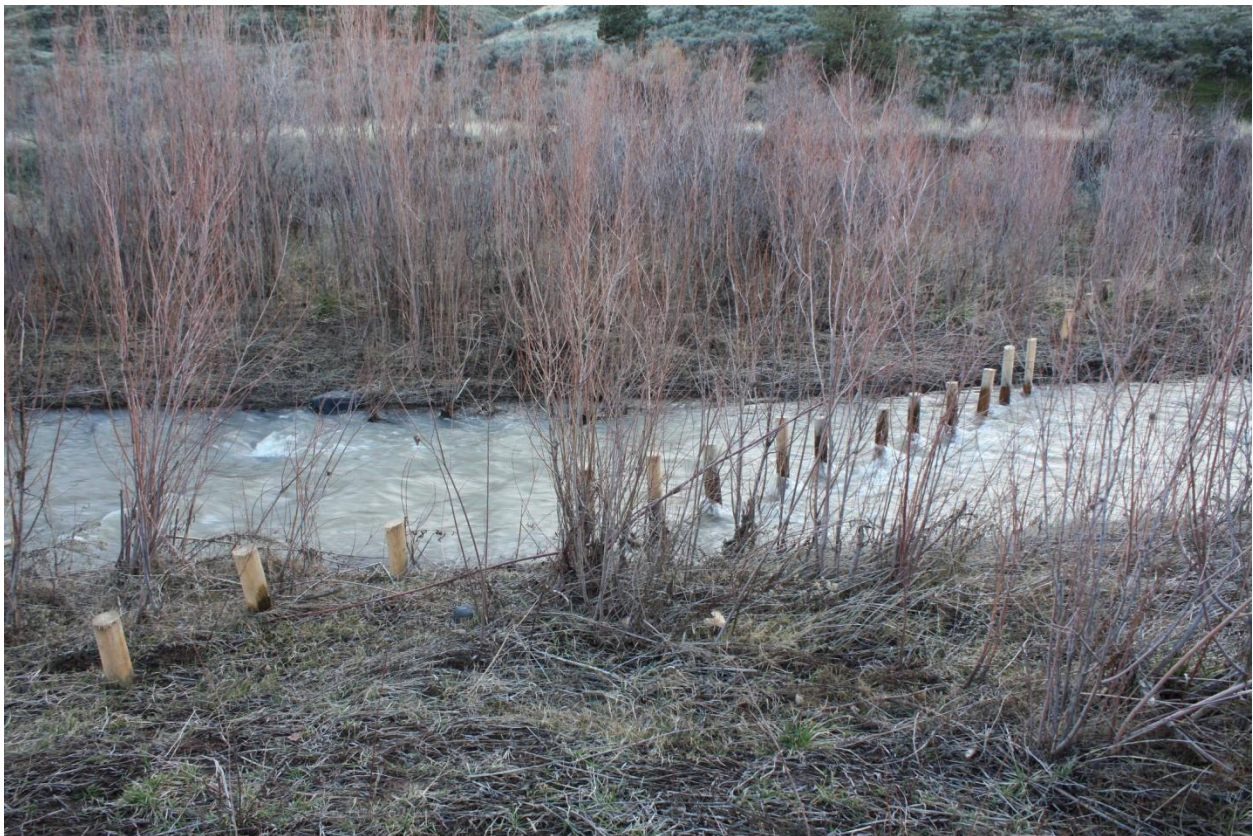
**Figure 12.** The purpose of a post line is to provide a site where beaver can build a stable dam. They generally create little or no geomorphic changes unless utilized by beaver.

Post Lines (Figure 12) were placed in sites where a future beaver dam was desired and where geomorphic conditions were suitable for a dam. In contrast to PLWW, post lines by themselves were limited to sites where there was minimal risk if no aggradation occurred because beaver did not use them to build a dam. These structures were not intended to be functional unless beaver utilized them to build a dam.

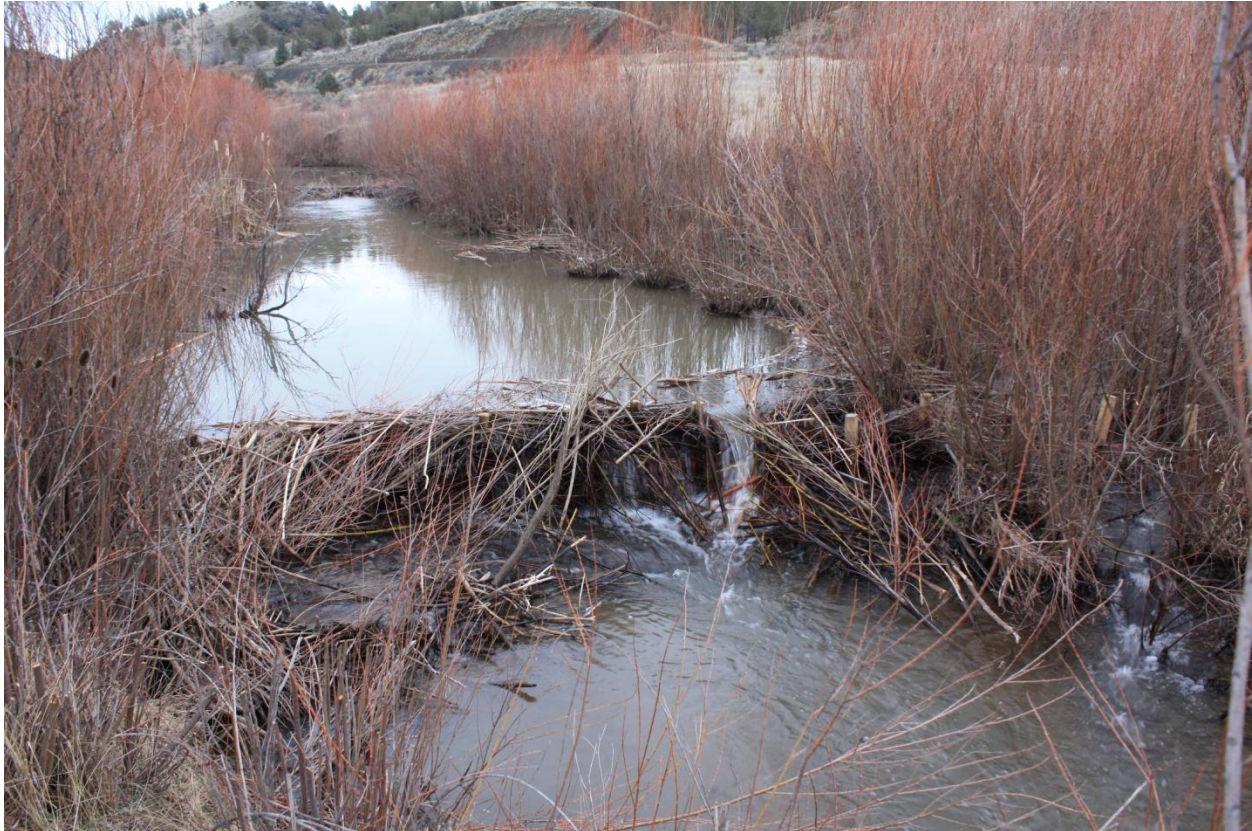
**Figure 13.** Any active dams within the treatment areas were strengthened with posts to lengthen their functional life, since most dams along the incised Bridge Creek have been shown to last less than a year (Demmer and Beschta, 2008). This structure was one of four dams built in sequence in Lower Owens to form a new colony. Within one year, all four dams had backfilled with sediment, which improved floodplain connectivity and habitat complexity, but made the site unsuitable for beaver. However, because we had installed additional post lines just downstream the beaver were able to use them to build new dams which allowed the colony to persist.

All active or intact abandoned beaver dams within the treatment areas were stabilized with posts (Figure 13) to lengthen their functional life, since most dams along the incised Bridge Creek have been shown to last less than a year (Demmer and Beschta, 2008). Any abandoned dams with significant structure remaining were reinforced (Figure 14). These were sites where beaver had previously built dams, and with additional structure available might do so again.

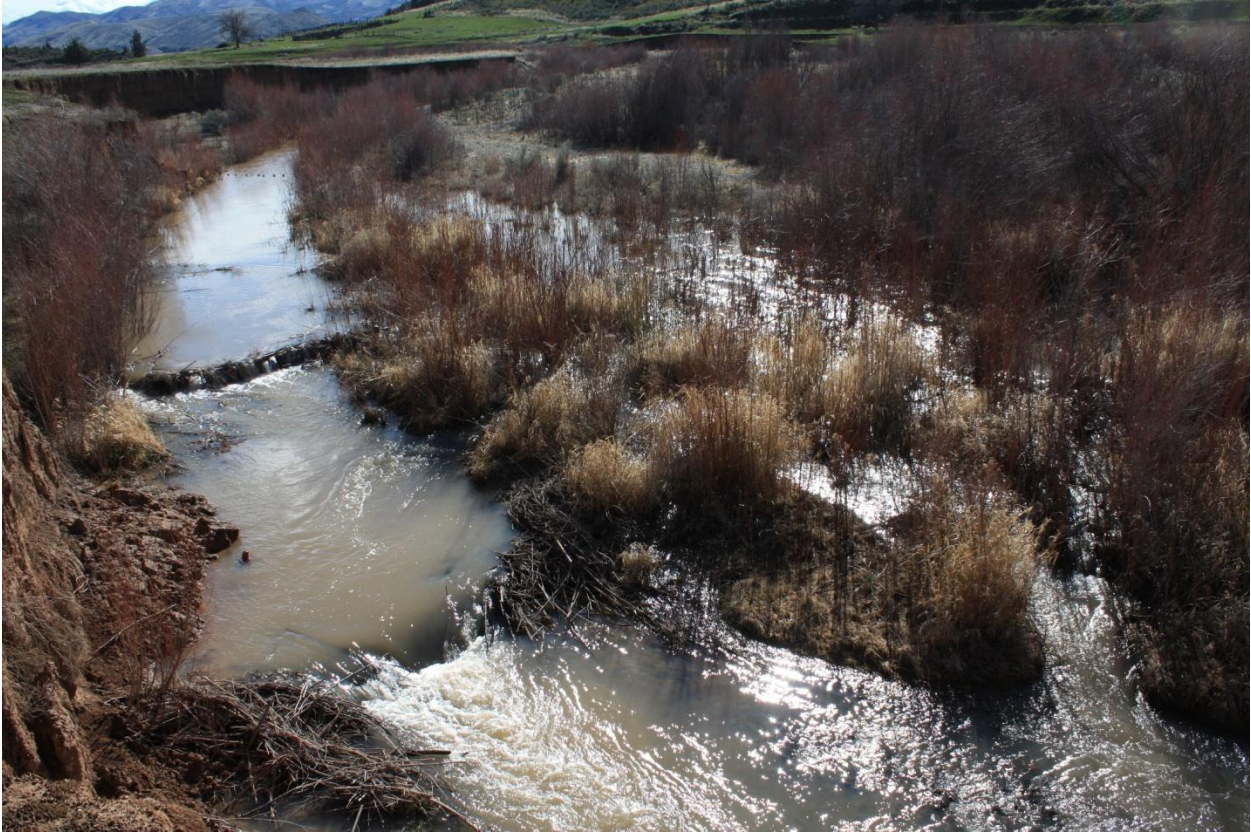
**Figure 14.** Any abandoned dams with significant structure remaining were also reinforced with posts, since these were sites where beaver had previously built dams, and with additional structure available might do so again. Beaver abandoned this dam (PC 15) and one immediately below it after it was breached by high flows. Within a year following reinforcement by posts, beaver rebuilt the dam and built two more dams on postlines immediately upstream (PC 13 and 14-just visible upstream in the photograph), resulting in a flooded terrace and complex, multichannel habitat forming on river left and diverting flow away from a high exposed bank or river right.
